Contract #: 04-0120F4Cty: SF/ALA Rte: 80 PM: 13.2/13.9File #: 69.28**WELDING INSPECTION REPORT****Resident Engineer:**Pursell, Gary**Address:** 333 Burma Road**City:** Oakland, CA 94607**Report No:** WIR-014870**Date Inspected:** 09-Jun-2010**Project Name:** SAS Superstructure**OSM Arrival Time:** 1900**Prime Contractor:** American Bridge/Fluor Enterprises, a JV**OSM Departure Time:** 700**Contractor:** Zhenhua Port Machinery Company, Ltd (ZPMC), Changxing Island **Location:** Shanghai, China**CWI Name:** See Below**CWI Present:** Yes No**Inspected CWI report:** Yes No N/A**Rod Oven in Use:** Yes No N/A**Electrode to specification:** Yes No N/A**Weld Procedures Followed:** Yes No N/A**Qualified Welders:** Yes No N/A**Verified Joint Fit-up:** Yes No N/A**Approved Drawings:** Yes No N/A**Approved WPS:** Yes No N/A**Delayed / Cancelled:** Yes No N/A**Bridge No:** 34-0006**Component:** OBG**Summary of Items Observed:**

**OBG Segment Trial Assembly**

## WELDING INSPECTION REPORT

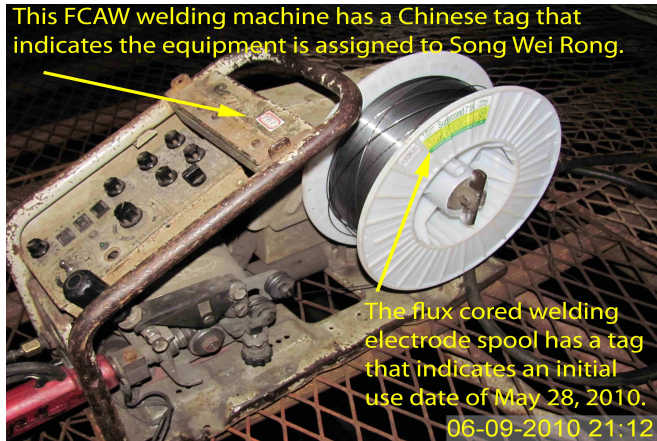
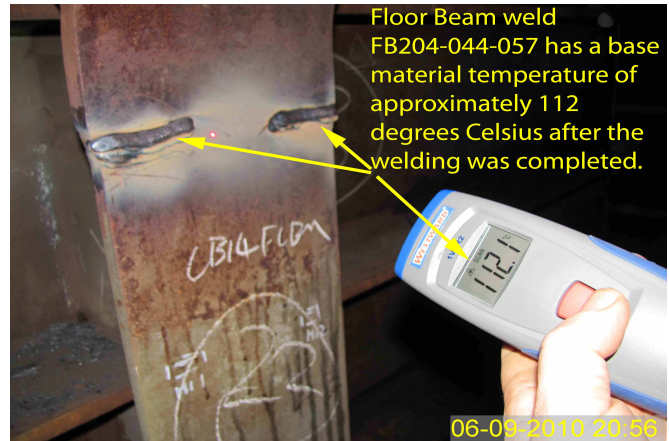
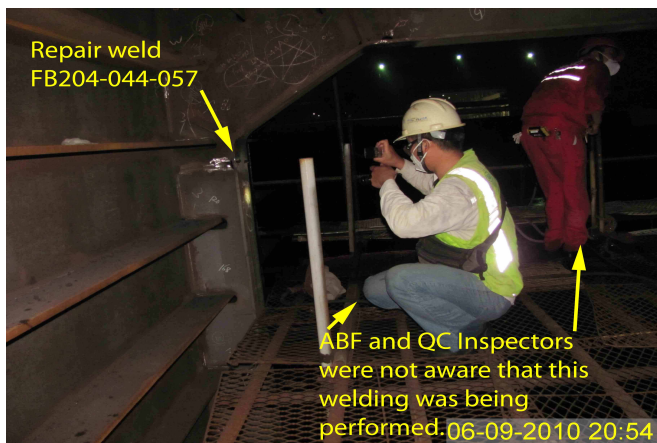
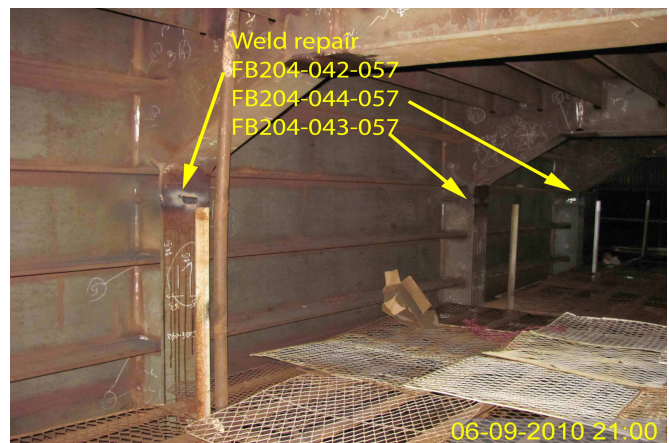
OBG Cross Beam located in the yard behind bay 14

This QA Inspector observed a ZPMC welder appears to be performing welding inside OBG segment cross beam CB14. When this QA Inspector approached cross beam CB14 the welder stopped welding and left the cross beam.

This QA Inspector asked ZPMC QC Inspector (not a CWI) Mr. Wang Zhu and ABF representative Mr. Wang Zhong Yuan if they were aware if anyone was welding in cross beam CB14 and both people said they were not aware of any welding being performed inside cross beam CB14. This QA Inspector observed that an unidentified ZPMC welder appears to have performed weld repairs of ultrasonic rejections of welds FB204-042-057, FB204-043-057 and FB204-044-057 without a Quality Control Certified Welding Inspector being aware of the welding or monitoring this welding. ZPMC QC and ABF personnel were not aware if welding repair documents have been issued for this work and the depth of the weld repairs and other related information does not appear to have been recorded to determine if critical weld repair documents were required and who performed these welding repairs. No acetylene torch or other heating equipment was in the vicinity of the weld repair areas they do not appear to have been preheated prior to welding. The welding machine has a Chinese language label on the top of the machine and ABF representative Mr. Wang Zhong Yuan said the tag indicates this welding machine is assigned to ZPMC welder Mr. Song Wei Rong. The spool of flux cored welding electrode on the FCAW machine has a label that indicates the welding electrode was initially used on May 28, 2010 which is approximately thirteen days ago. This QA Inspector informed ZPMC QC Inspector Mr. Wang Zhu and ABF representative Mr. Wang Zhong Yuan that an incident report is being issued to document the items mentioned above. For additional information, see the attached photographs below.
